CONSTRUCTION VIBRATION MONITORING SUMMARY REPORT

NOVEMBER 1- NOVEMBER 30, 2015

**VIRGINIA AVENUE TUNNEL RECONSTRUCTION PROJECT
WASHINGTON, DC**

**Prepared by:
Gannett Fleming Inc.**

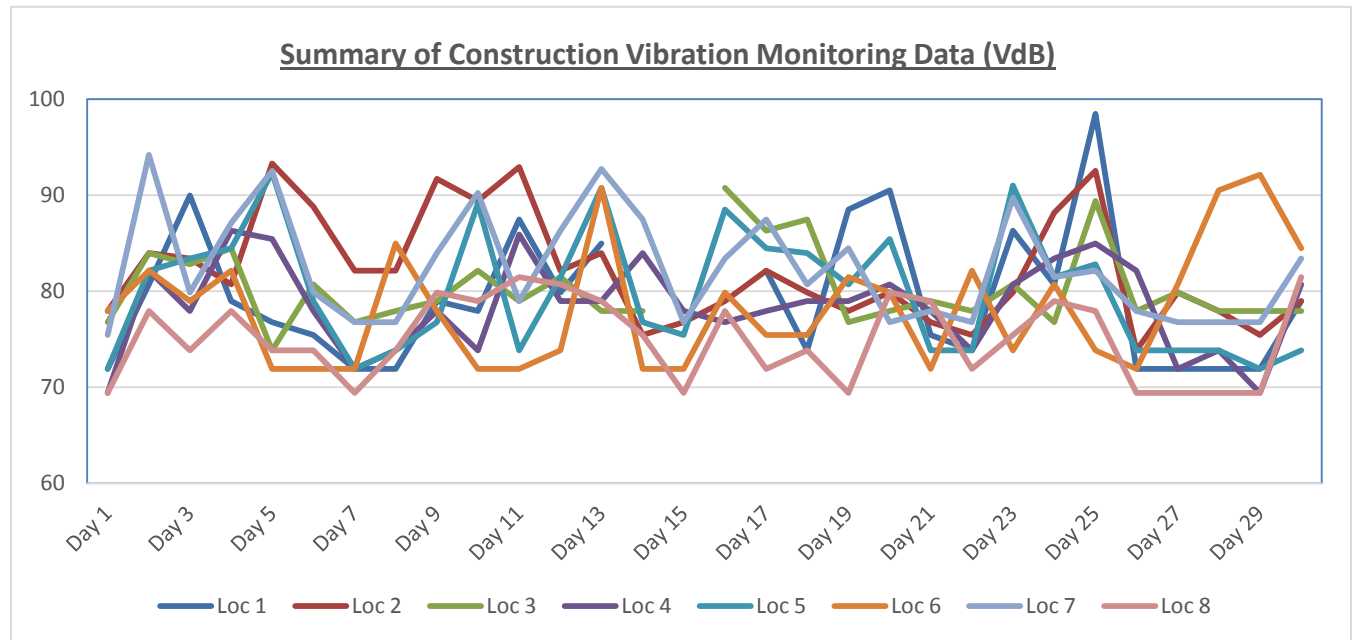
Figure 2. Summary of Construction Vibration Monitoring Data (VdB) – November 2015

Table 2 presents the results of the maximum vibration levels measured during the month of November 2015 and shows how the measured levels compare to the established vibration criteria. The average daily vibration level results are plotted in Figure 2. No exceedances were recorded during the month.
