CONSTRUCTION VIBRATION MONITORING SUMMARY REPORT

JANUARY 1- JANUARY 31, 2016

**VIRGINIA AVENUE TUNNEL RECONSTRUCTION PROJECT
WASHINGTON, DC**

**Prepared for:
CSX Transportation**

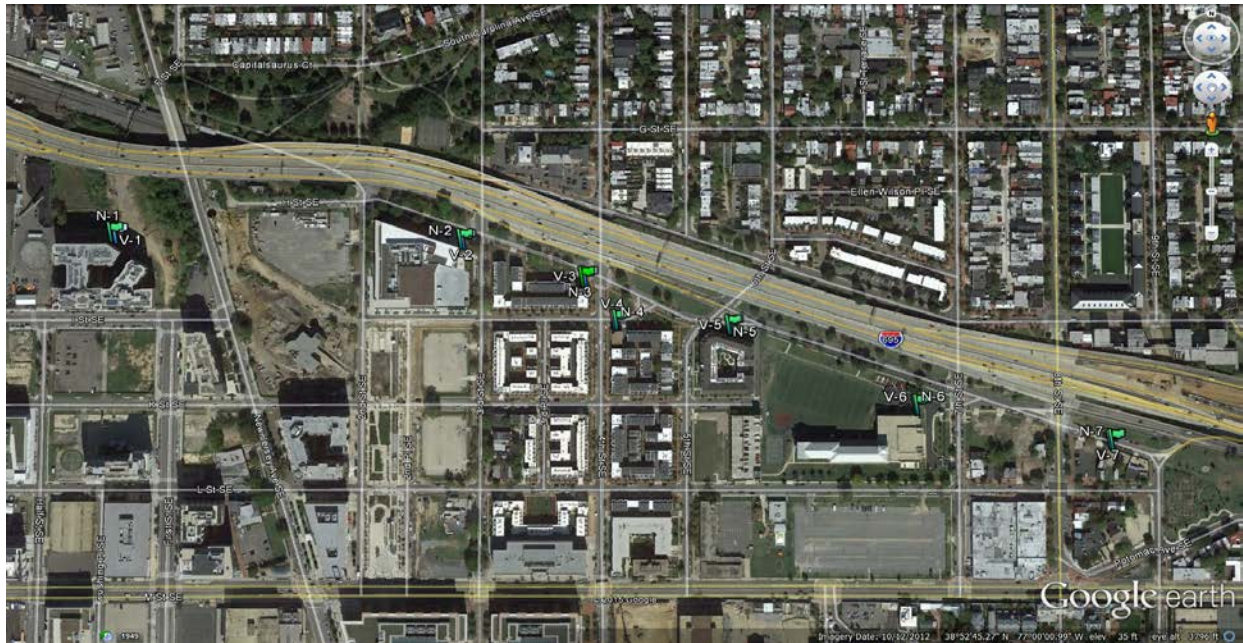
Figure 1. Vibration Monitoring Locations

Construction vibration level data was collected for the reporting period starting January 1 through January 31, 2016. Eight fixed vibration monitoring locations were measured continuously to monitor vibration levels since the beginning of major construction activities in May 2015. Vibration level data was collected every minute for the duration of the vibration monitoring period. The locations of the monitoring stations are depicted in Figure 1 and the addresses described in Table 1.

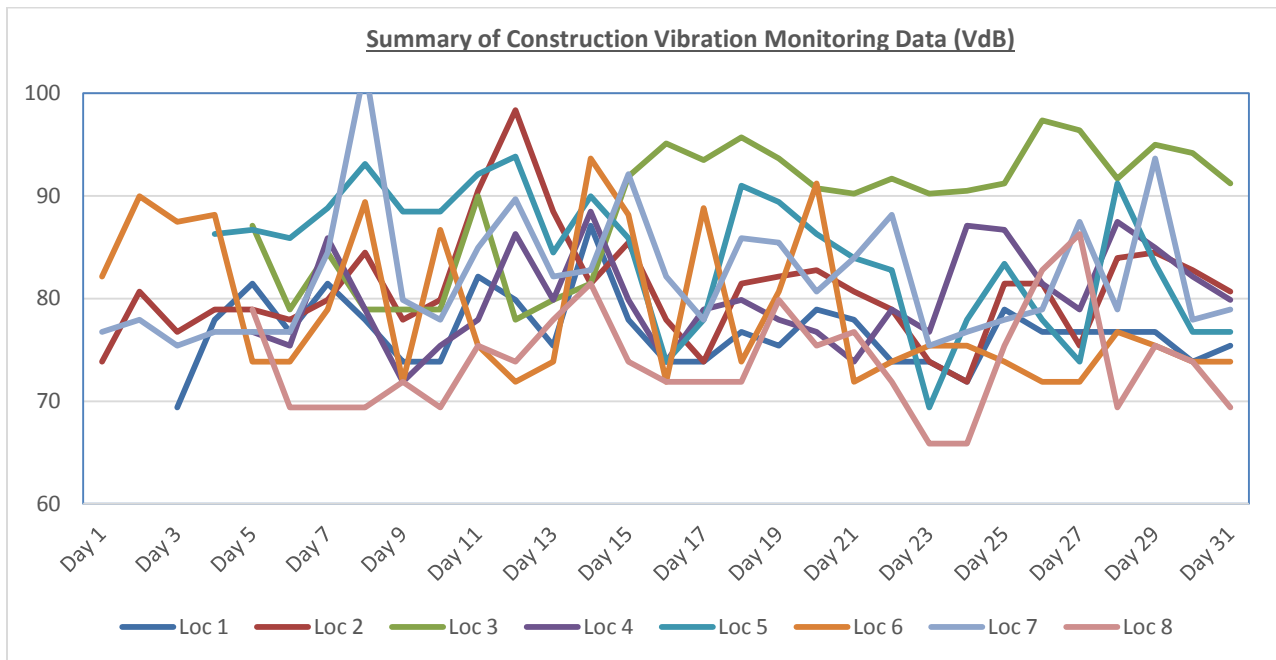
Figure 2. Summary of Construction Vibration Monitoring Data (VdB) – January 2016

Table 2 presents the results of the maximum vibration levels measured during the month of January 2016 and show how the measured levels compare to the established vibration criteria. The average daily vibration level results are plotted in Figure 2. An exceedance of the vibration criteria was recorded during pile drilling activities at Location 7. However, the infrequent rate of occurrence (three times during the month) and the short duration of the events (1 to 3 seconds) are not expected to cause damage to any of the nearby structures at Location 7.
