CONSTRUCTION VIBRATION MONITORING SUMMARY REPORT

FEBRUARY 1 – MARCH 4, 2017

**VIRGINIA AVENUE TUNNEL RECONSTRUCTION PROJECT
WASHINGTON, DC**

**Prepared by:
Gannett Fleming Inc.**

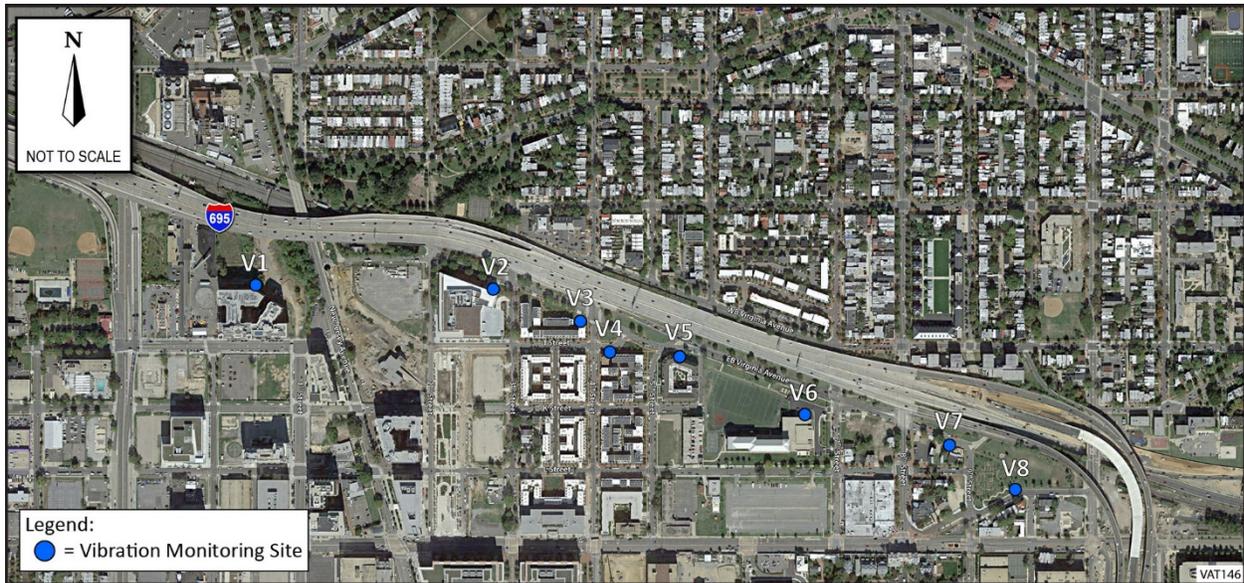
Figure 1. Vibration Monitoring Locations

Construction vibration level data was collected for the reporting period starting February 1 through March 4, 2017. Eight fixed vibration monitoring locations have been measured continuously to monitor vibration levels since the beginning of major construction activities in May 2015. Vibration level data was collected every minute for the duration of the vibration monitoring period. The locations of the monitoring stations are depicted in Figure 1 and the addresses described in Table 1.

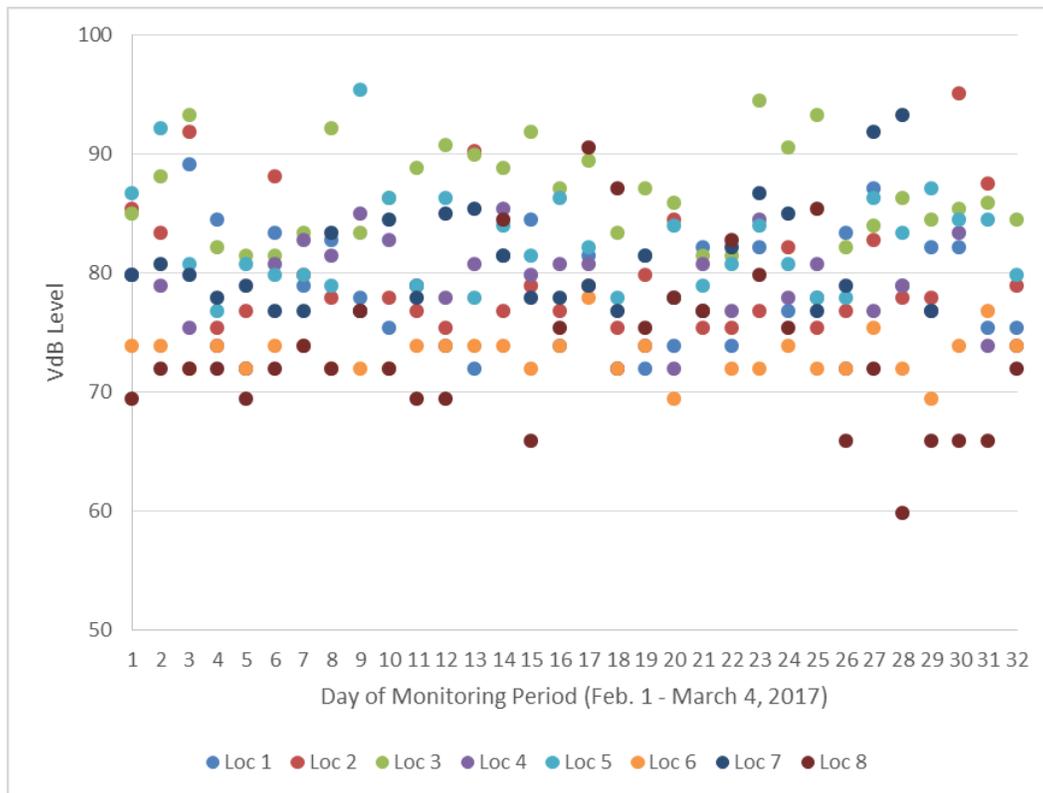
Figure 2. Summary of Maximum Daily Construction Vibration Monitoring Data (VdB) – February 2017

Table 2 presents the maximum and average vibration levels measured during the month of February 2017 and shows how the measured levels compare to the established vibration criteria. The maximum daily vibration level for each of the eight monitor locations is plotted in Figure 2. A single exceedance of the potential building damage vibration criteria was recorded at Location 5 during construction activities. However, the rate of occurrence (once during the month) and the short duration of the event (less than 3 seconds) is not expected to cause damage to any of the nearby structures at this location. Figure 3 plots the average daily levels (reflecting the average of all measurements recorded during each 24-hour period) for the same locations. On most days, several locations are represented by the same average level and are plotted by a single dot – resulting in fewer than 8 dots on any given date. [Note that Locations 1 and 8 did not record data on two days during the period due to power losses and equipment maintenance activities.]
