CONSTRUCTION VIBRATION MONITORING SUMMARY REPORT

FEBRUARY 1 – MARCH 4, 2017

**VIRGINIA AVENUE TUNNEL RECONSTRUCTION PROJECT
WASHINGTON, DC**

**Prepared by:
Gannett Fleming Inc.**

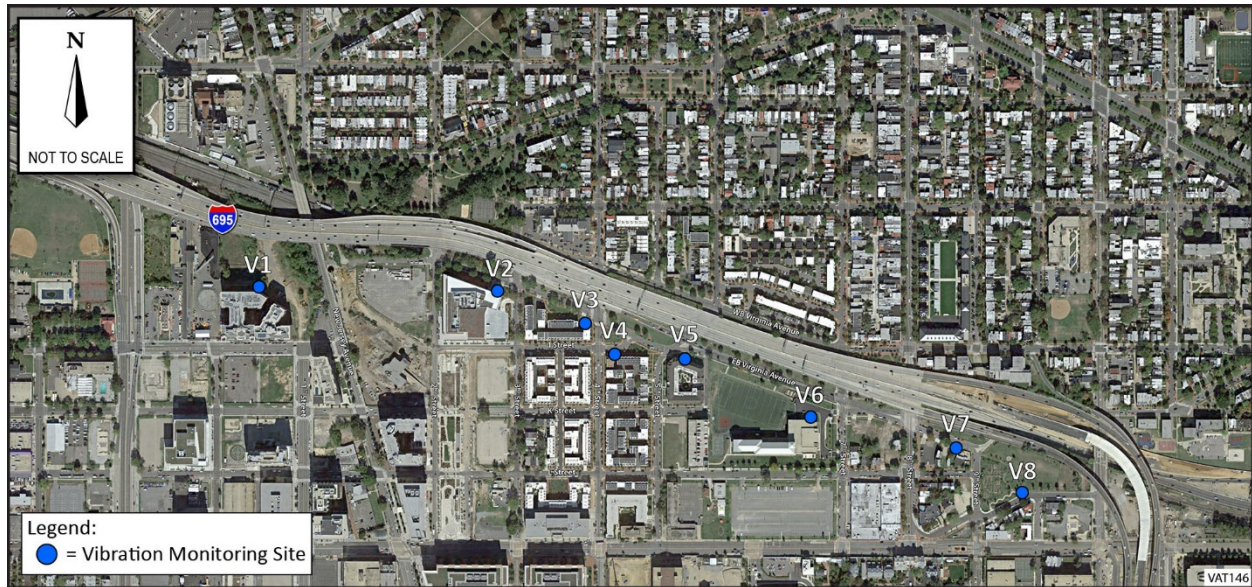
Figure 1. Vibration Monitoring Locations

Construction vibration level data was collected for the reporting period starting February 1 through March 4, 2017. Eight fixed vibration monitoring locations have been measured continuously to monitor vibration levels since the beginning of major construction activities in May 2015. Vibration level data was collected every minute for the duration of the vibration monitoring period. The locations of the monitoring stations are depicted in Figure 1 and the addresses described in Table 1.

Site ID	Vibration Monitoring Location
V1	West of New Jersey Avenue SE
V2	Corner of 3 rd Street and Virginia Avenue SE
V3	Between 3 rd Street and 4 th Street SE, in front of Townhomes
V4	Corner of 4 th Street SE and I Street SE
V5	Corner of 5 th Street and Virginia Avenue SE, in front of Capper Senior Apartments
V6	Adjacent to fence of Marine Corp Recreational Facility on 6 th Street SE
V7	Between 8 th and 9 th Streets SE, in front of Commercial Buildings
V8	Virginia Avenue Park

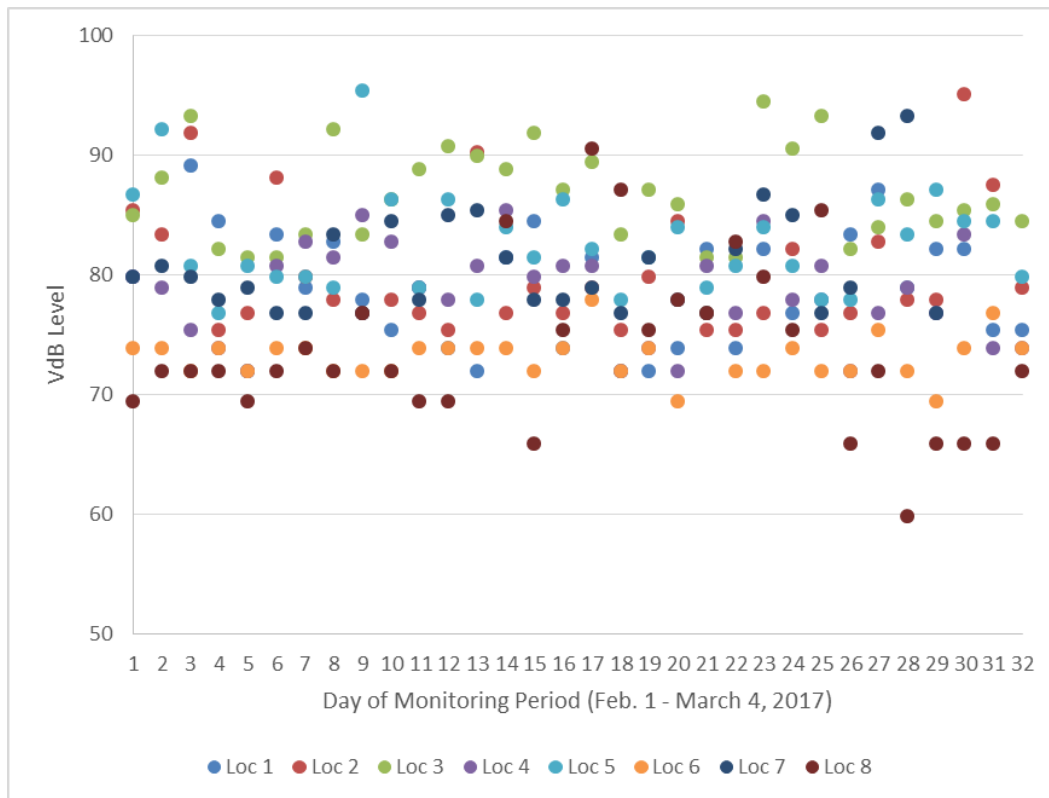
Figure 2. Summary of Maximum Daily Construction Vibration Monitoring Data (VdB) – February 2017

Table 2 presents the maximum and average vibration levels measured during the month of February 2017 and shows how the measured levels compare to the established vibration criteria. The maximum daily vibration level for each of the eight monitor locations is plotted in Figure 2. A single exceedance of the potential building damage vibration criteria was recorded at Location 5 during construction activities. However, the rate of occurrence (once during the month) and the short duration of the event (less than 3 seconds) is not expected to cause damage to any of the nearby structures at this location. Figure 3 plots the average daily levels (reflecting the average of all measurements recorded during each 24-hour period) for the same locations. On most days, several locations are represented by the same average level and are plotted by a single dot – resulting in fewer than 8 dots on any given date. [Note that Locations 1 and 8 did not record data on two days during the period due to power losses and equipment maintenance activities.]
