CONSTRUCTION VIBRATION MONITORING SUMMARY REPORT

JANUARY 1 – JANUARY 31, 2017

**VIRGINIA AVENUE TUNNEL RECONSTRUCTION PROJECT
WASHINGTON, DC**

**Prepared by:
Gannett Fleming Inc.**

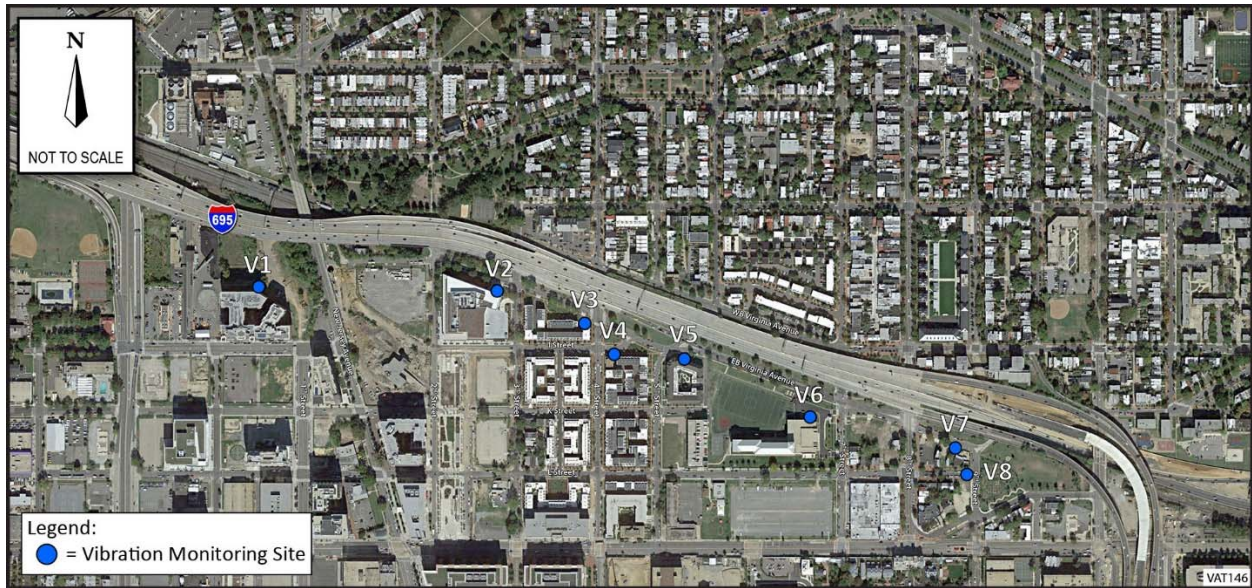
Figure 1. Vibration Monitoring Locations

Construction vibration level data was collected for the reporting period starting January 1 through January 31, 2017. Eight fixed vibration monitoring locations have been measured continuously to monitor vibration levels since the beginning of major construction activities in May 2015. Vibration level data was collected every minute for the duration of the vibration monitoring period. The locations of the monitoring stations are depicted in Figure 1 and the addresses described in Table 1.

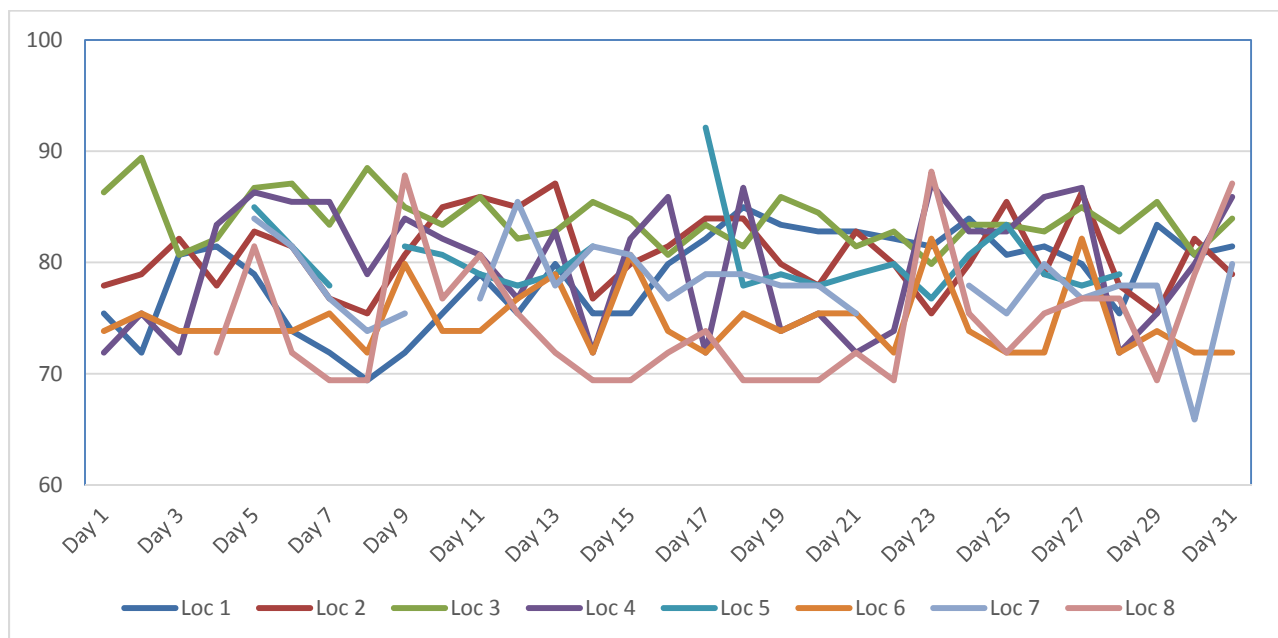
Figure 2. Summary of Construction Vibration Monitoring Data (VdB) – January 2017

Table 2 presents the results of the maximum vibration levels measured during the month of January 2017 and shows how the measured levels compare to the established vibration criteria. The average daily vibration level results are plotted in Figure 2. There were no exceedances of the vibration criteria recorded for construction operations during the period. [Note that Locations 5, 7 and 8 did not record data on several days during the period due to power losses and equipment maintenance activities.]
