CONSTRUCTION VIBRATION MONITORING SUMMARY REPORT

JULY 1 - JULY 31, 2016

**VIRGINIA AVENUE TUNNEL RECONSTRUCTION PROJECT
WASHINGTON, DC**

Construction Vibration Monitoring Summary

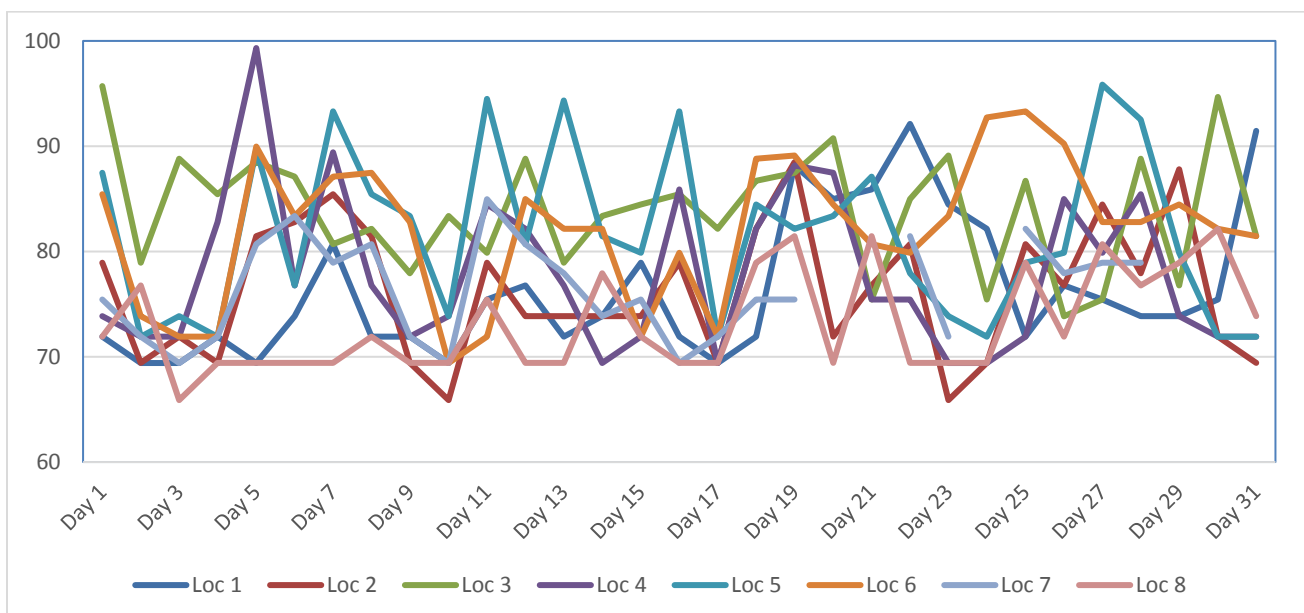
Figure 2. Summary of Construction Vibration Monitoring Data (VdB) – July 2016

Table 2 presents the results of the maximum vibration levels measured during the month of July 2016 and show how the measured levels compare to the established vibration criteria. The average daily vibration level results are plotted in Figure 2. An exceedance of the vibration criteria was recorded during construction at Locations 4 and 5. However, the infrequent rate of occurrence (twice during the month at each location) and the short duration of the event (less than 3 seconds for each event) is not expected to cause damage to any of the nearby structures at either location. [Note that Location 7 did not record data on July 20, 21, 24 and 29-31 due to power losses caused by severe thunderstorms.]
