CONSTRUCTION VIBRATION MONITORING SUMMARY REPORT

JULY 1 –31, 2017

**VIRGINIA AVENUE TUNNEL RECONSTRUCTION PROJECT
WASHINGTON, DC**

**Prepared by:
Gannett Fleming Inc.**

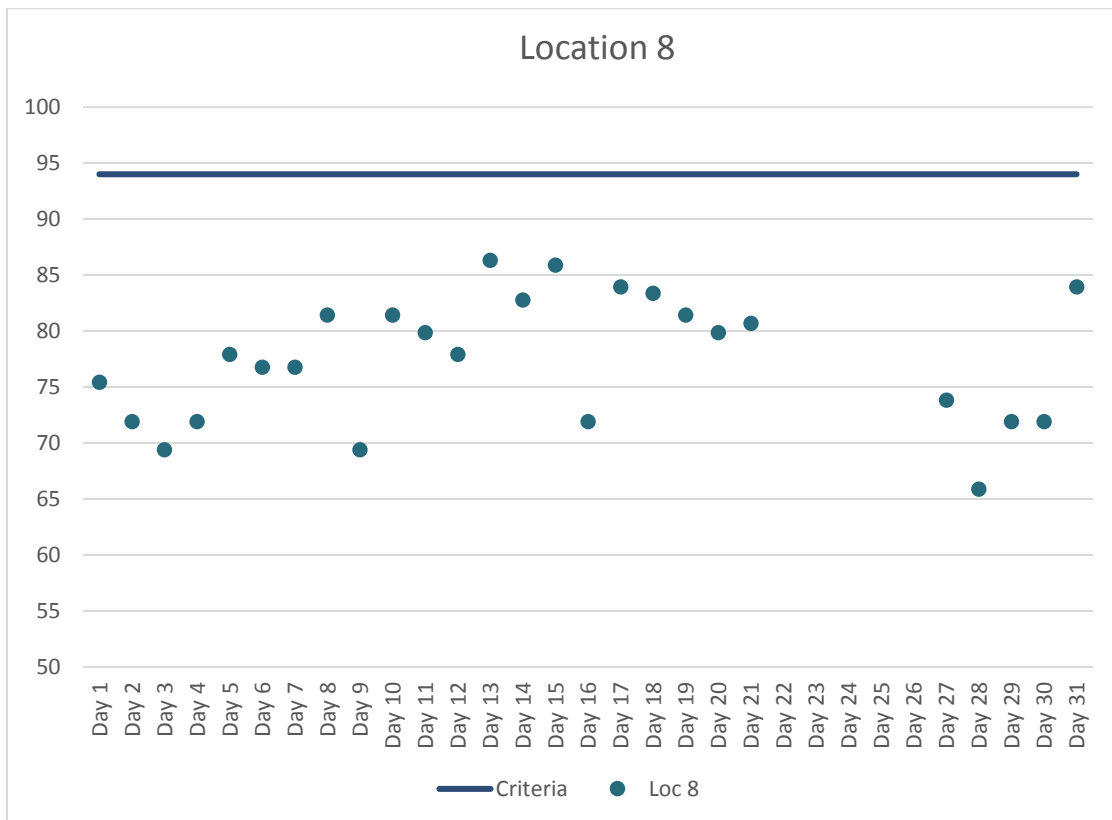
[Note that Location 3 did not record data on two days and Location 8 did not record data on five days during the period due to power losses and equipment maintenance activities]

| Site ID | Vibration Monitoring Location | Maximum Level Recorded | | Monthly Average Level | | Structural Damage Criteria ^{a,b} | | Number of Exceedances |
|---|---|---|---|---|---|---|---|---|
| V8 | Virginia Avenue Park | 86 | 0.08 | 64 | 0.008 | 94 ^f | 0.2 ^f | 0 |

Figure 9. Location 8 Maximum Daily Construction Vibration Monitoring Data (VdB) – July 2017
